# Bluff Point Wind Farm and Studland Bay Wind Farm Annual Environmental Review 2019

March 2020

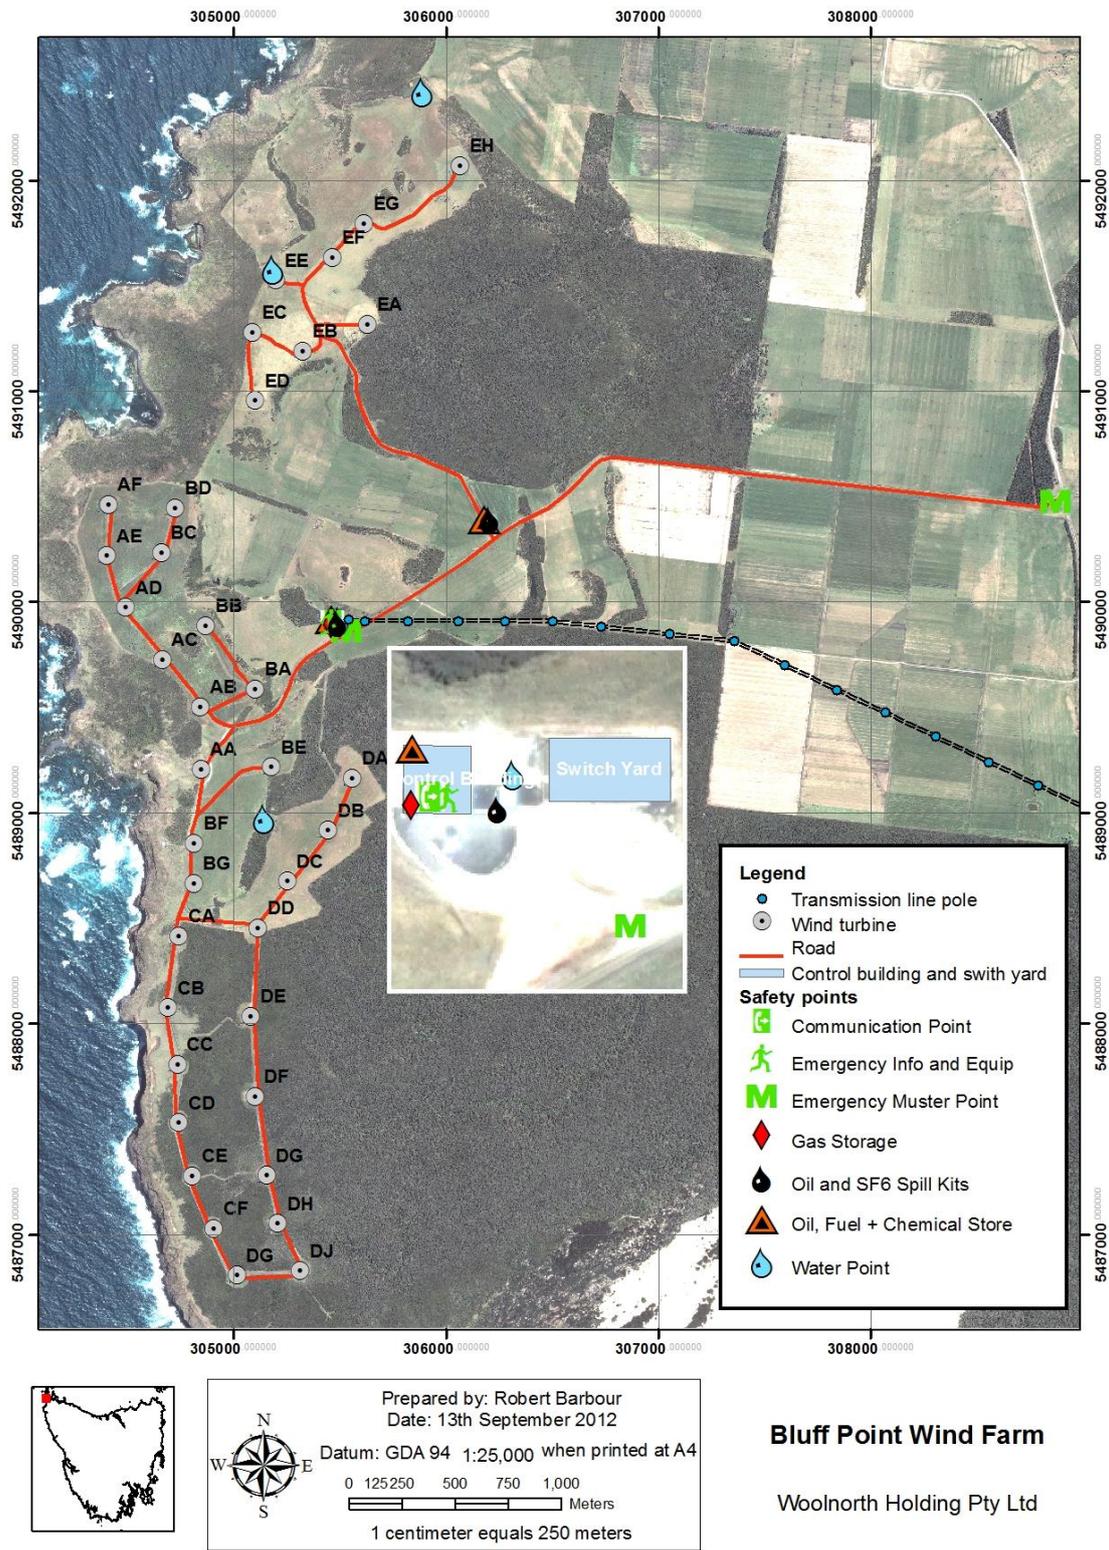
Figure 1. Bluff Point Wind Farm

BPWF was developed in two stages. The first stage comprised the construction of six turbines, with an electrical connection to the Smithton substation via a 22kV power line. Stage 2 comprised an additional 31, 1.75MW turbines, and the construction of the 110kV transmission line from the wind farm switchyard to the Smithton substation. In total BPWF comprises 37 Vestas V66, 1.75MW turbines and was fully commissioned in August 2004 with a generation capacity of 64.75MW. Refer to Figure 1 for the layout of BPWF.

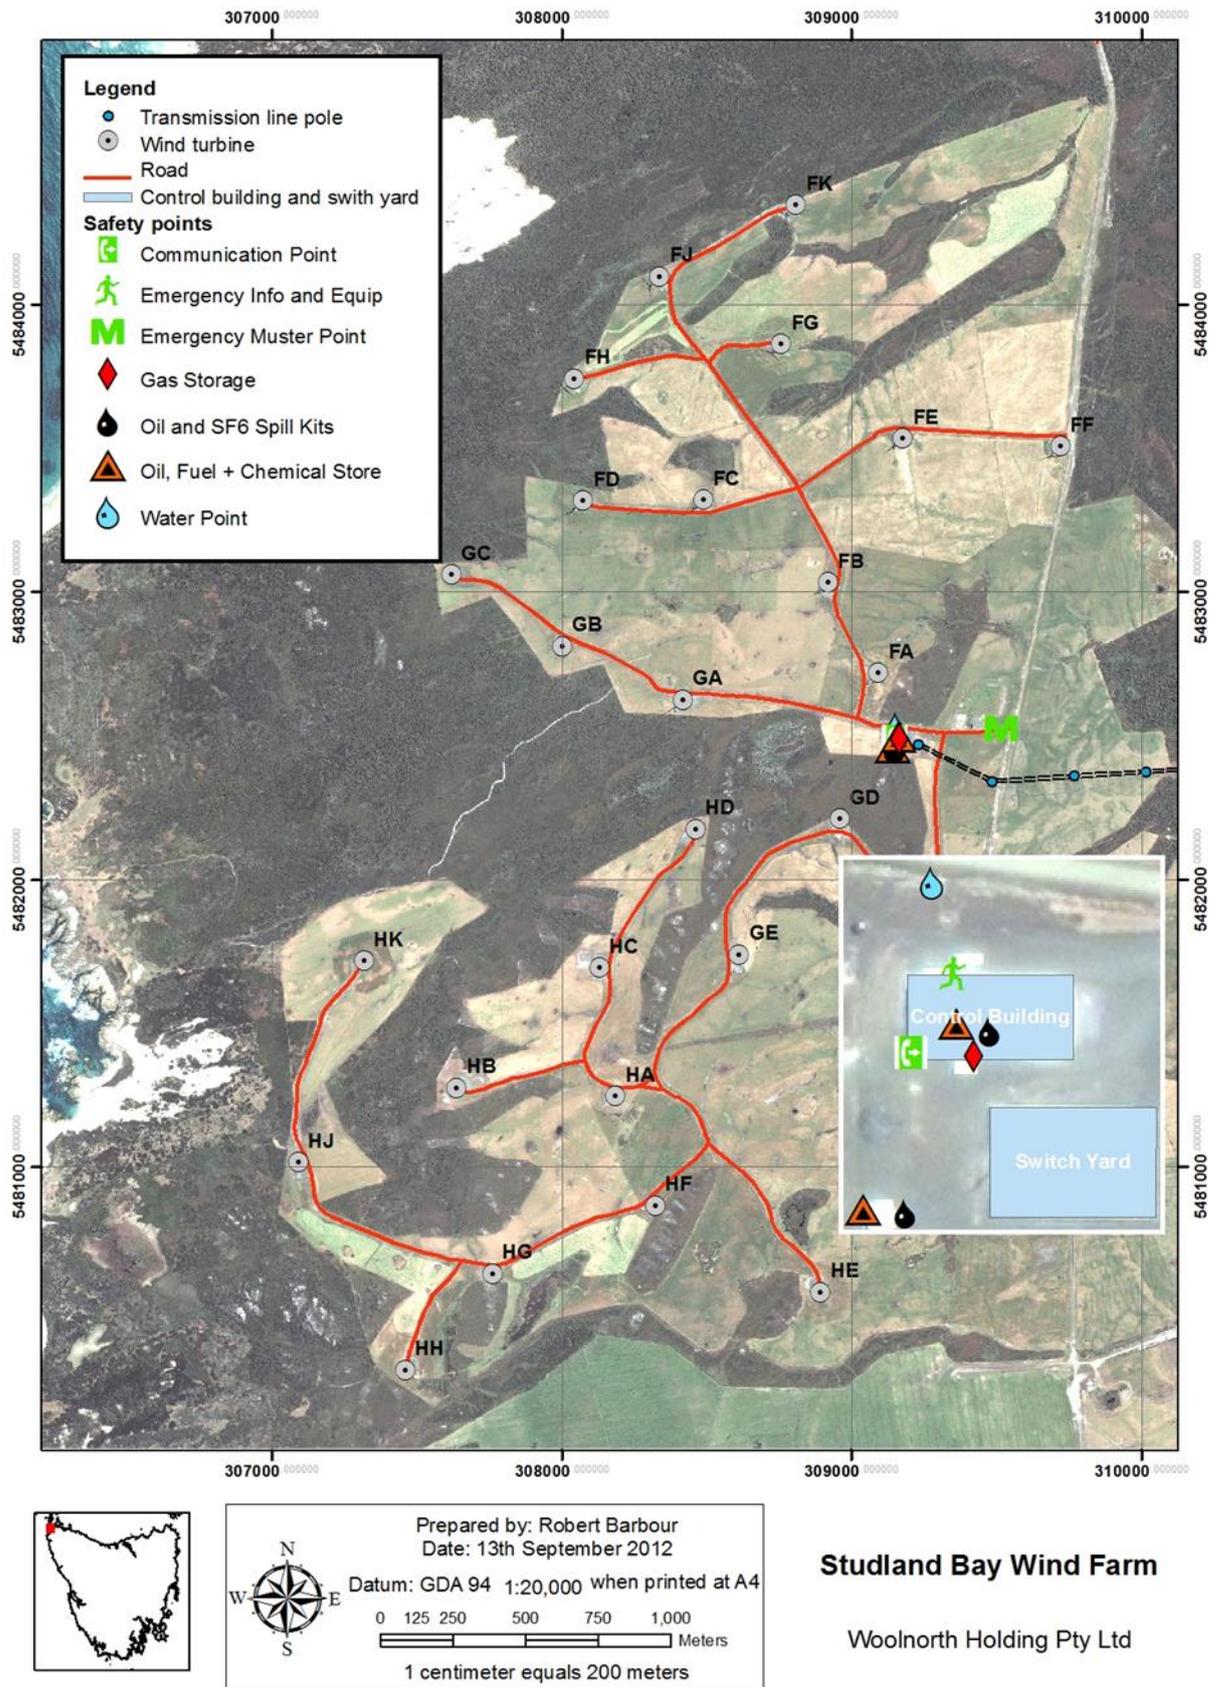
Figure 2. Studland Bay Wind Farm

Construction commenced on SBWF in 2006 with a nominal capacity of 75MW. The development of SBWF included construction of a spur transmission line to connect to the existing 110kV transmission line between BPWF and the substation at Smithton. SBWF consists of 25 Vestas V90, 3MW turbines and was fully commissioned by 1 June 2007. Figure 2 details the layout of SBWF, while the transmission line route is shown in Figure 3.

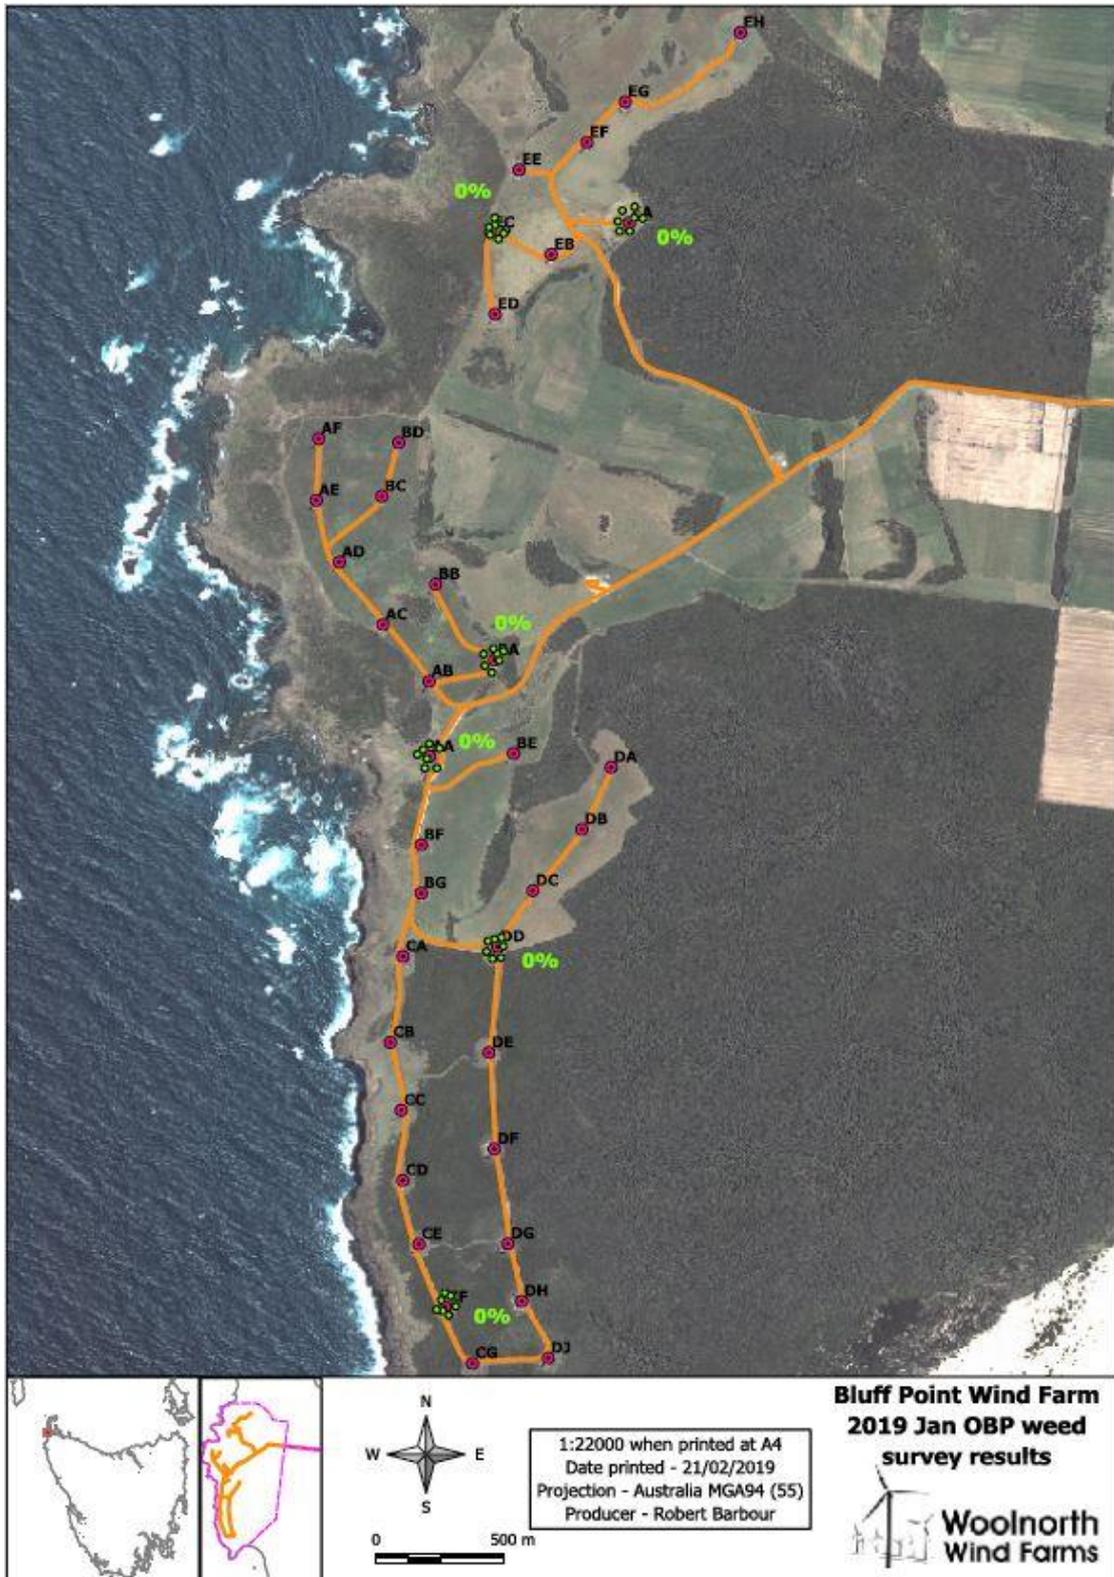
Figure 4. BPWF weed survey locations and combined average results (%) of OBP foraging species

Figure 4 (above) outlines the combined average of OBP foraging species at each sampled turbine site. As can be seen from the results, none of the five OBP weed species were identified in any of the surveyed wind turbine areas and hence all wind turbines areas were deemed a 'PASS'. On the basis of the wind turbine area results, the site was also deemed a 'PASS'.

Turbines EC, EA, BA, AA, DD and CF were randomly selected (using Random function in Excel).

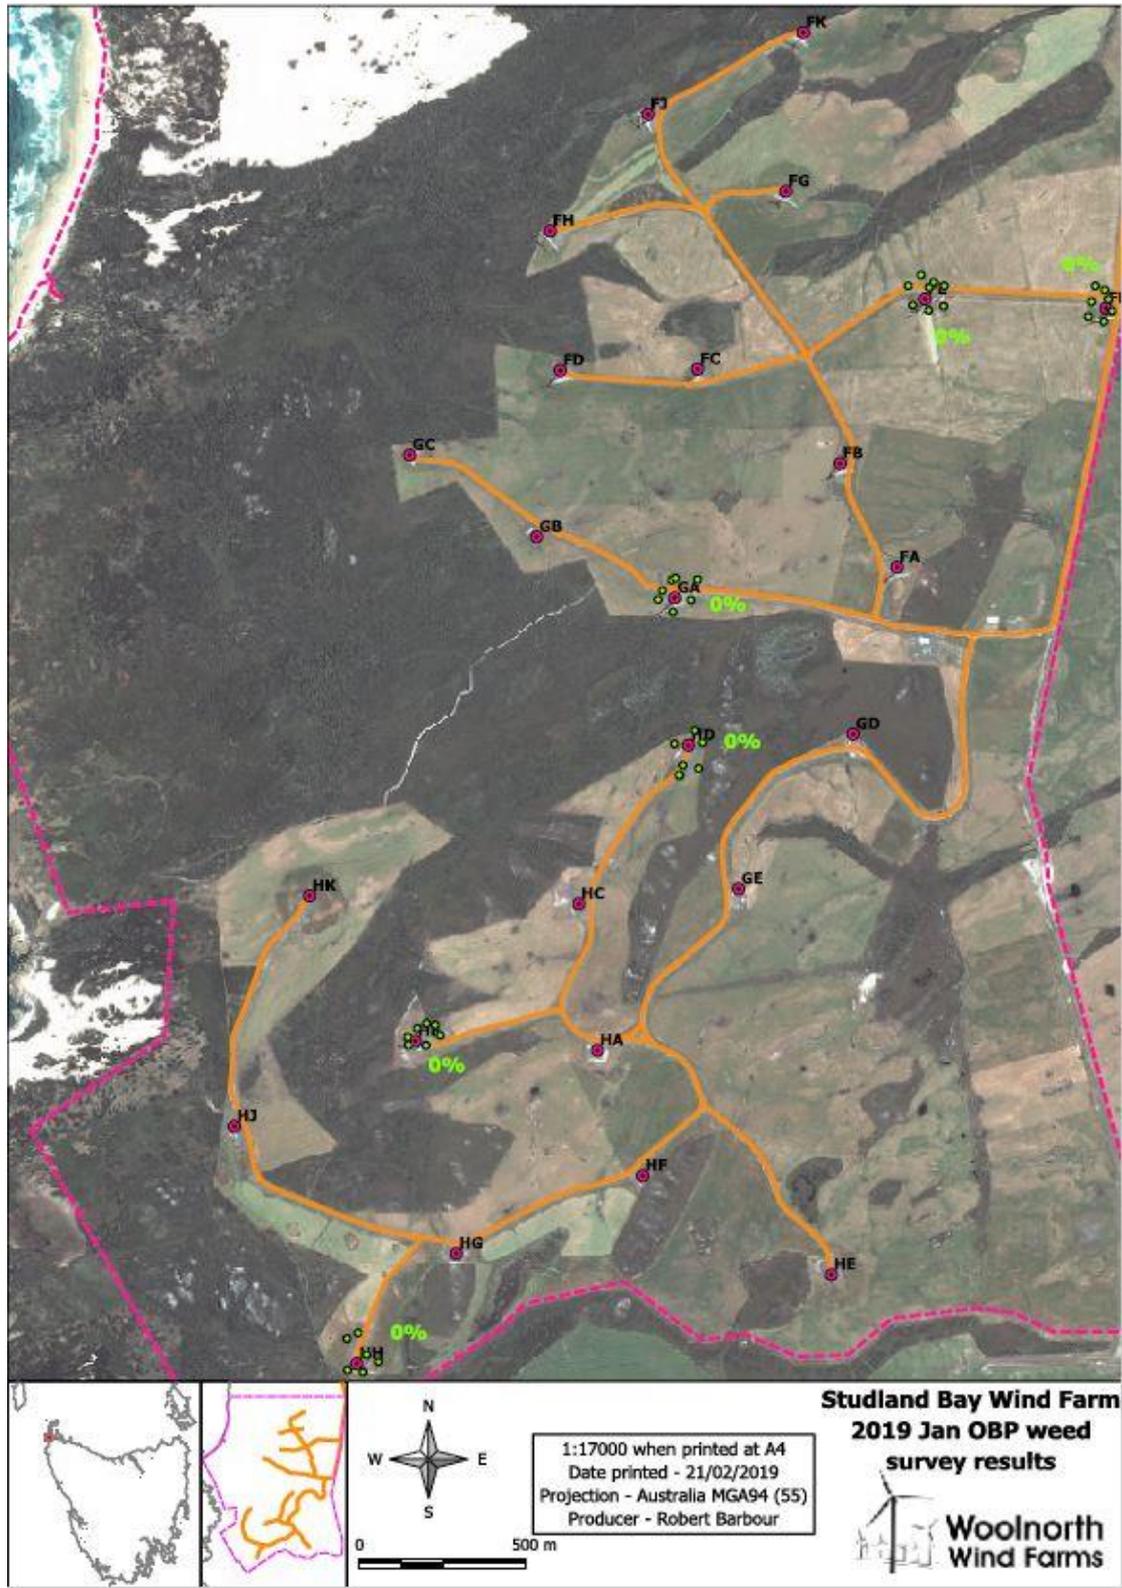
Figure 5 below outlines the combined average of OBP foraging species at each sampled turbine site. As can be seen from the results none of the five OBP weed species were identified in any of the surveyed wind turbine areas and hence all wind turbines areas were deemed a 'PASS'.

Figure 5. SBWF weed survey locations and combined average results (%) of OBP foraging species

Turbines FD, FE, GA, HD, HB and HH were randomly selected (using Random function in Excel).
