Musselroe Wind Farm Annual Environmental Review 2020-21

30 September 2021

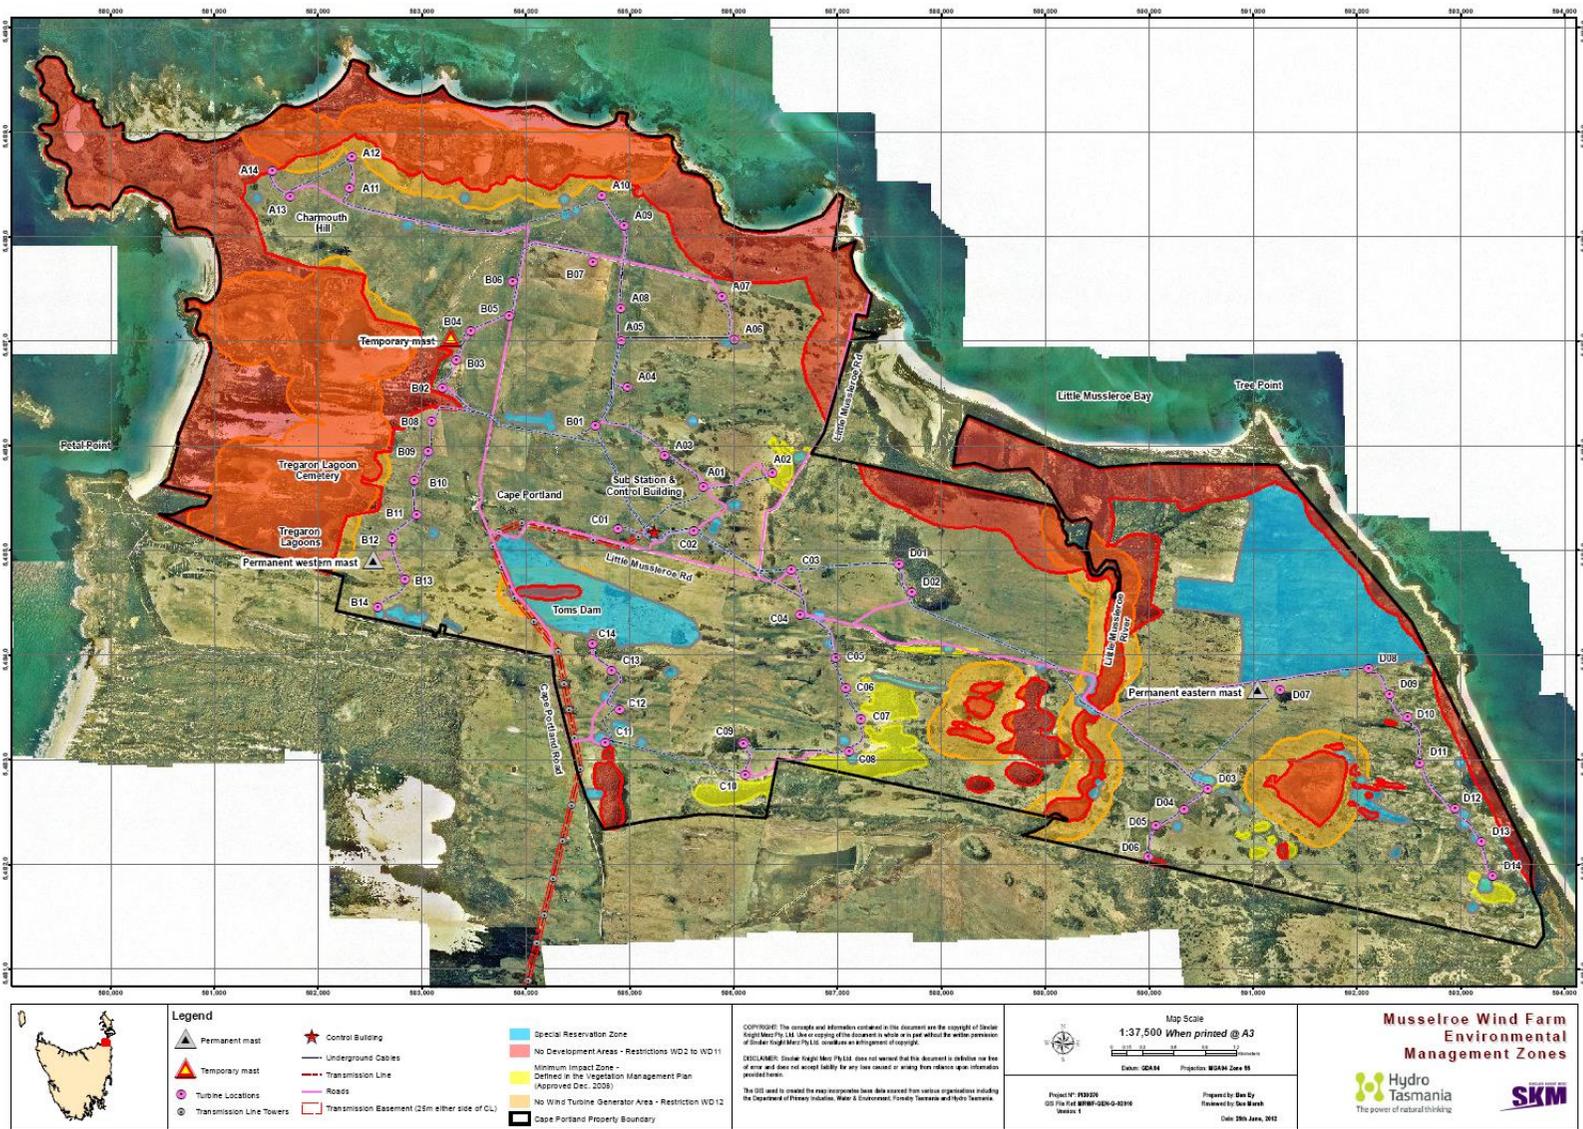
Figure 1. Musselroe Wind Farm layout

- 56 Vestas (3MW) wind turbines.
- Underground 33kV power collection system.
- An electrical substation, control room and associated buildings.
- Roads, fences and other associated infrastructure.
- A 110kV single circuit transmission line (49km in length, Figure 2), connecting the wind farm to the national electricity grid at the Derby substation.

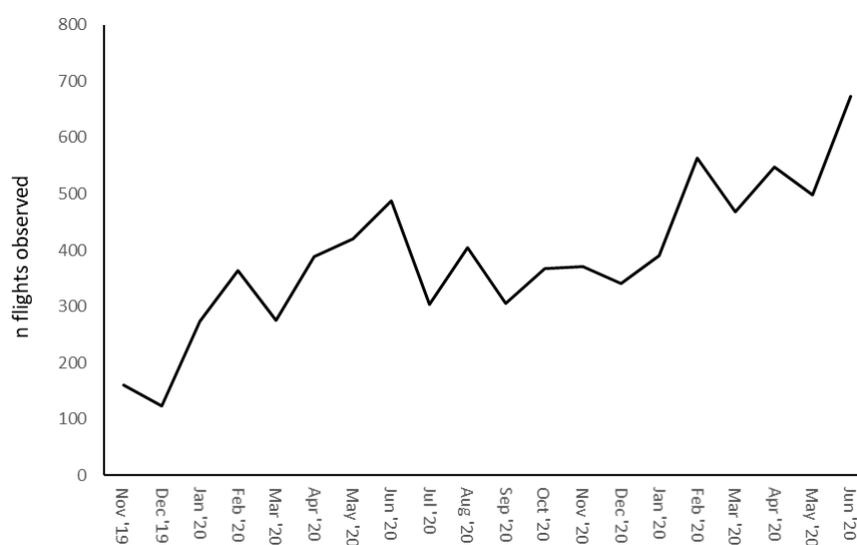
Figure 3. Number of wedge-tailed eagle flights observed from the start of the observer-based shutdown program in November 2019 through to the end of the 2020-21 reporting period.

While detailed analysis of the eagle observation and turbine shutdown data has not yet been conducted, since commencement of the program in November 2019, there have been approximately 400 WTE flights observed every month (Figure 3), with a strong relationship seen between the number of birds and the number of turbine shutdowns. The gradual increase in the number of flights that is evident in Figure 3 is largely due to the build-up in the observer effort i.e. number of observers and number of hours in a day.

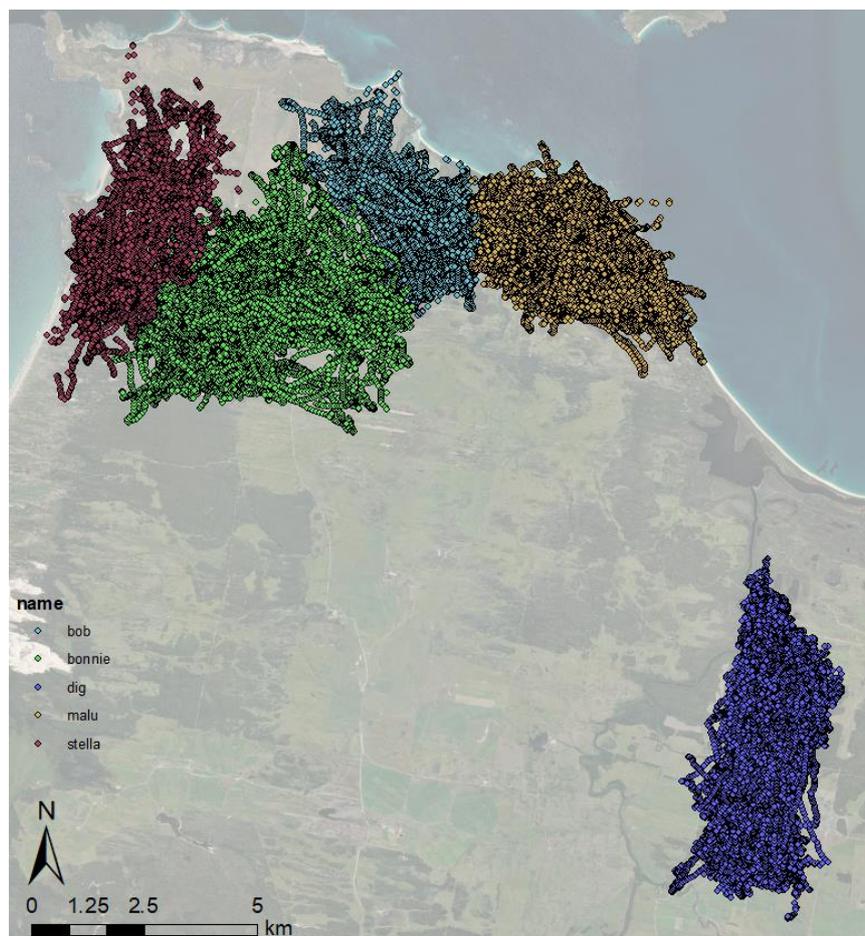
Figure 4. Example of the spatial data generated from the GPS tracked adult wedge-tailed eagles on and adjacent to the Musselroe Wind Farm (approx. 30 days).

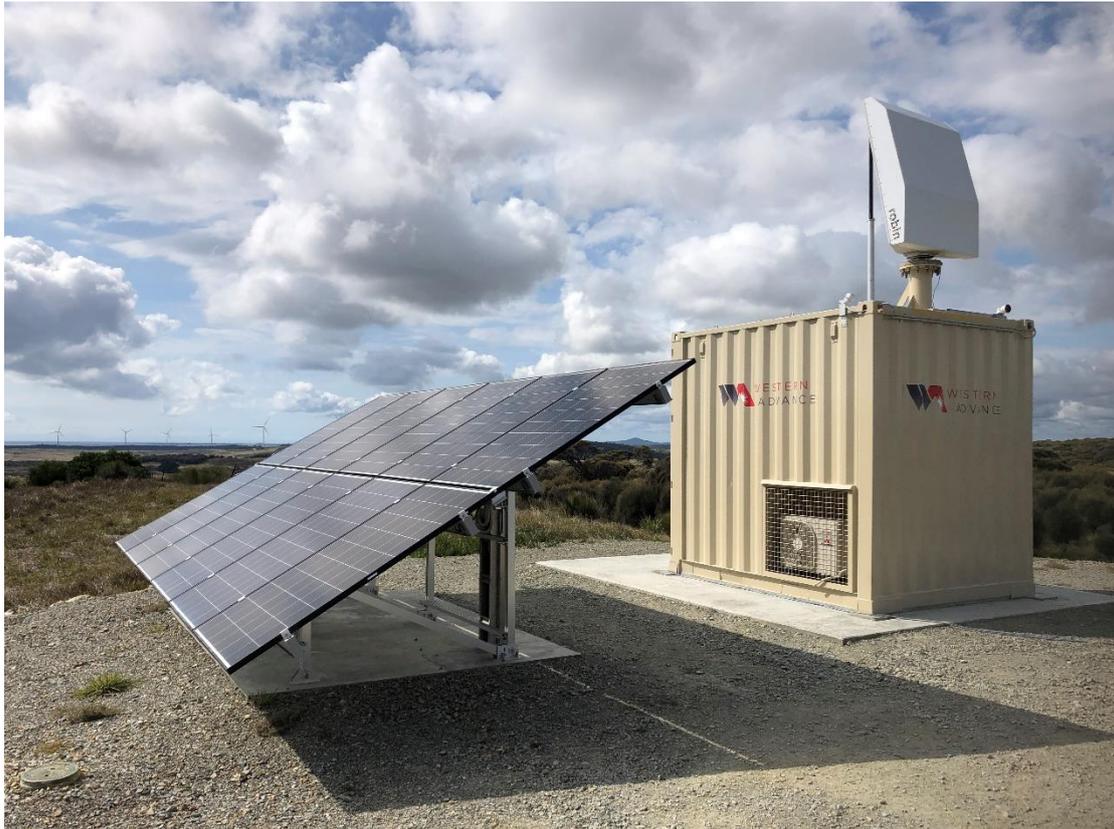
Figure 6. Installation and commissioning of the Robin Radar system was completed in October 2020. This included the back-up solar power supply and the lightning conductor mast in the background.

The radar was installed in late August 2020 and commissioned in September. Testing continued through to October until which point the unit was considered operational. Figure 5 show the location of the radar at MRWF, and Figure 6 shows the physical installation as at the end of the reporting period.

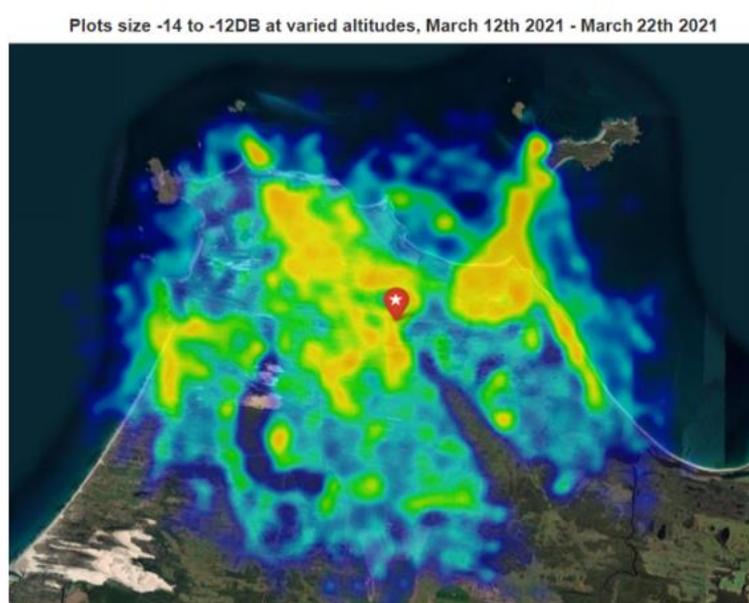
- Areas of low coverage in the vicinity of wind turbines to the far south east
- Areas of low coverage around wind turbines in the far north west
- Areas of low/patchy coverage around a series of turbines in the west of the wind farm

Figure 7. Coverage diagram for the period March 12-22, 2021 – all birds (high utilisation areas shown in yellow scaling to areas of no utilisation or coverage shown with no colour shading).

- Other conclusions drawn by Robin Radar regarding coverage:
 - For wind turbines in the immediate vicinity of the radar, high clutter is created by these turbines creating an area of low coverage behind and around them.

- A direct correlation between ground slope and clutter intensity is observed.

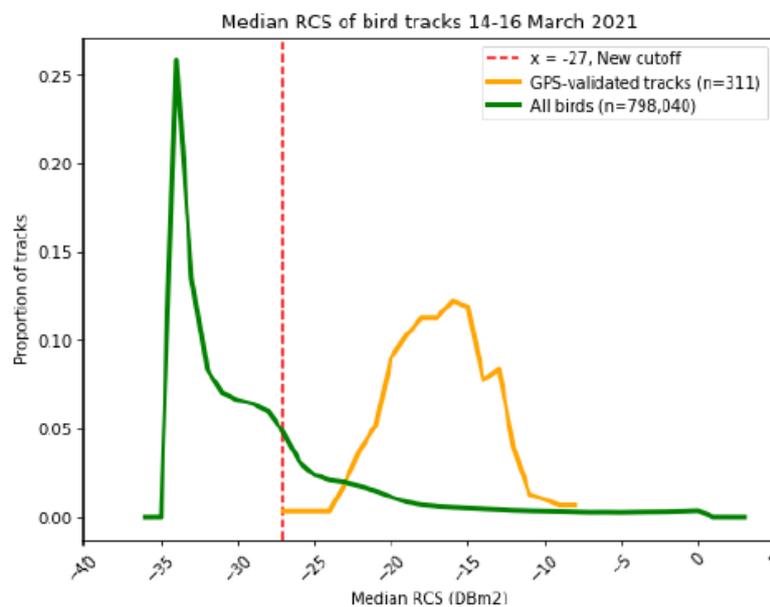
Figure 8. Median RCSA for all birds and the GPS tracked eagles.

- An initial concern raised by WNR was that validated eagle tracks were predominantly determined as medium sized birds by the radar. It was viewed as concern because one of the key parameters for the wind turbine shutdown automation is bird size.
- The radar distinguishes birds based on size classes – measuring radar cross sectional area (RCSA). Operational data confirmed eagles were measured by the radar across a wide RCSA range, with the median RCSA in the medium size class range
- Robin Radar have adjusted the RCSA classification to two categories. See Figure 8.
- There is now evidence that all eagle flights detected by the radar are classified in the same size class. The downside is a significant number of other birds are recognised by the radar in the same size class.

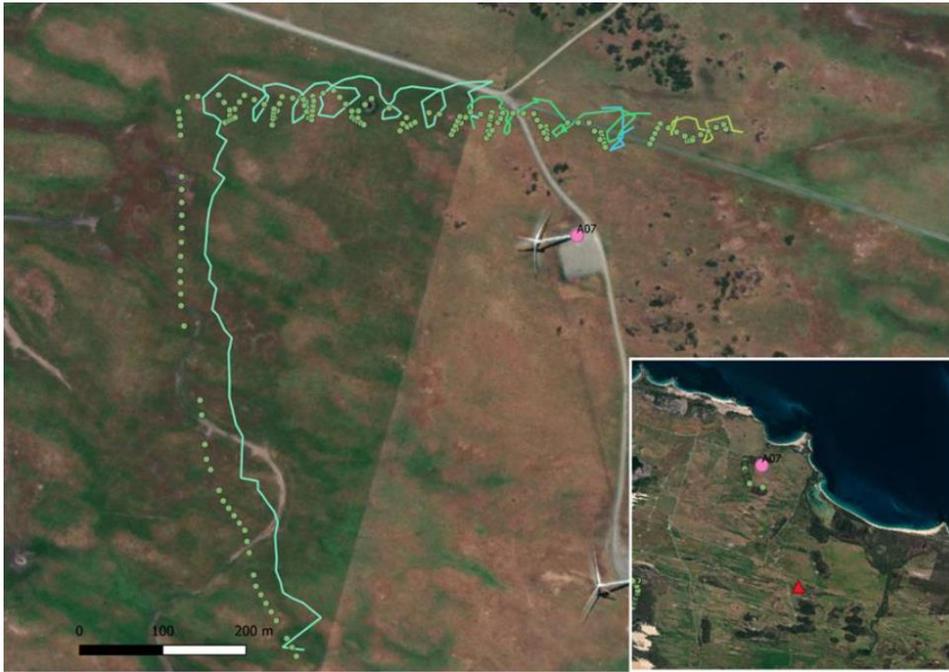
Figure 9. GPS track shown in dotted lines, compared with a broken radar track shown in solid lines (three separate tracks).

- It is evident that a large number of tracks close to wind turbines are generated by the turbines themselves. This issue has currently been dealt with by increasing the size of the non-detection zone around each turbine. This requires further refinement.
- Track break-up is an issue that is still being examined. It would appear from the data that improvements have been made. Turbine clutter may be part of the problem, as described above.
- The issue needs further assessment as the break-up of a track of interest (at a critical stage e.g. around or in a wind turbine shutdown buffer/alarm area) increases the risk of the system not operating effectively.
- Figure 9 below demonstrates the issue of track break up. In this particular example a known flight (GPS tracked bird) is tracked by the radar as three separate tracks.

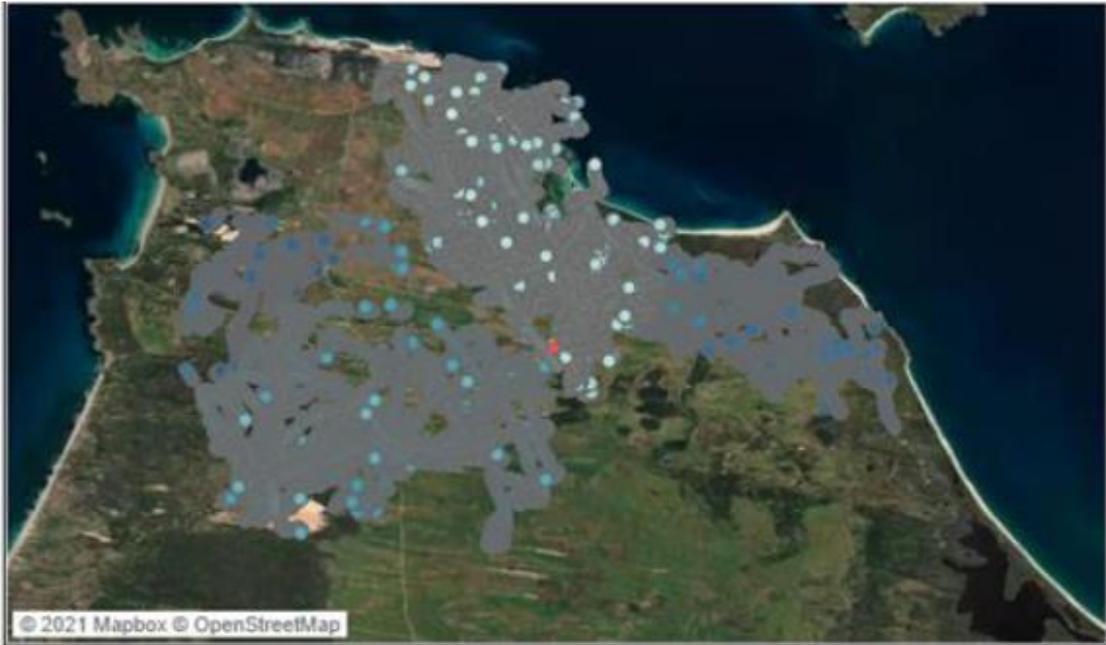
Figure 10. Spatial extent of the assessment of GPS track plots versus radar track plots (grey areas being GPS tracks).

By comparing the GPS track data with the radar track data, it is possible to assess what the radar system does not detect. For this assessment, the GPS track data was filtered to ensure that only flights that the radar could have seen were included. The assessment was also completed by comparing data points rather than complete tracks (tracks being made up of many data points).

Figure 10 below shows the spatial extent of the assessment (grey areas being GPS tracks)

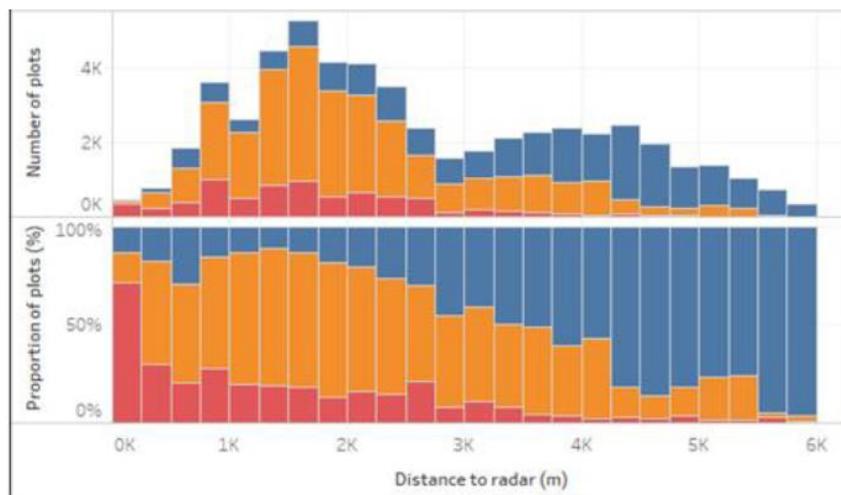
Figure 11. Assessment of GPS and Radar plot matching based on distance from the Radar (6km range was the limit of assessment, red plots were deemed not applicable or usable, orange are matched plots, blue indicated GPS plots not matched).

The results from this assessment revealed that overall, and on average, the correlation of radar plots to GPS plots was around 60%. This relatively mid-range percentage of matching being the result of areas of low matching and areas of higher matching. Figure 11 below provides an example of the assessment based on distance from the radar (noting – 6km range was the limit of assessment, red plots were deemed not applicable or usable, orange are matched plots, blue indicated GPS plots not matched).

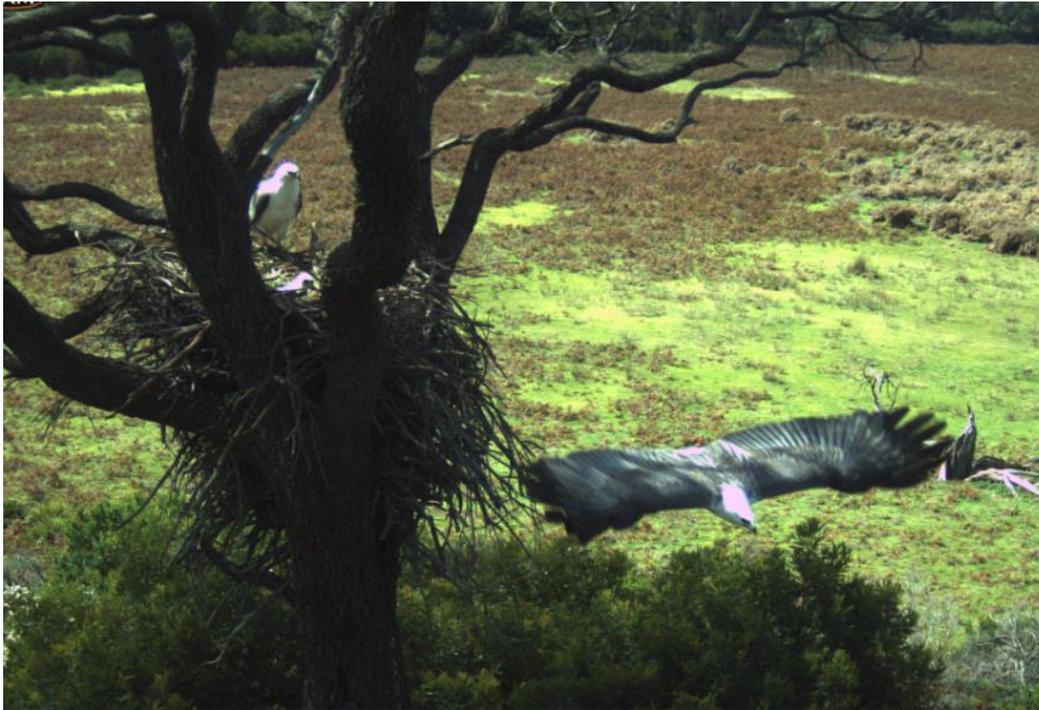
Figure 13. Wildlife camera photo of the white-bellied sea-eagles at Nest #2466. This nest was previously a WTE nest site (in early years).

Nest #2466 continued to be monitored with a discrete wildlife camera which has been maintained and in place since its installation in 2019. Two other nest sites were monitored in the same way, however these nest sites have all been lost due to tree failure (despite being active during the periods of monitoring). Figure 13 provides an example of the images being received.
