# Musselroe Wind Farm Annual Environmental Review 2025-26

30 September 2026

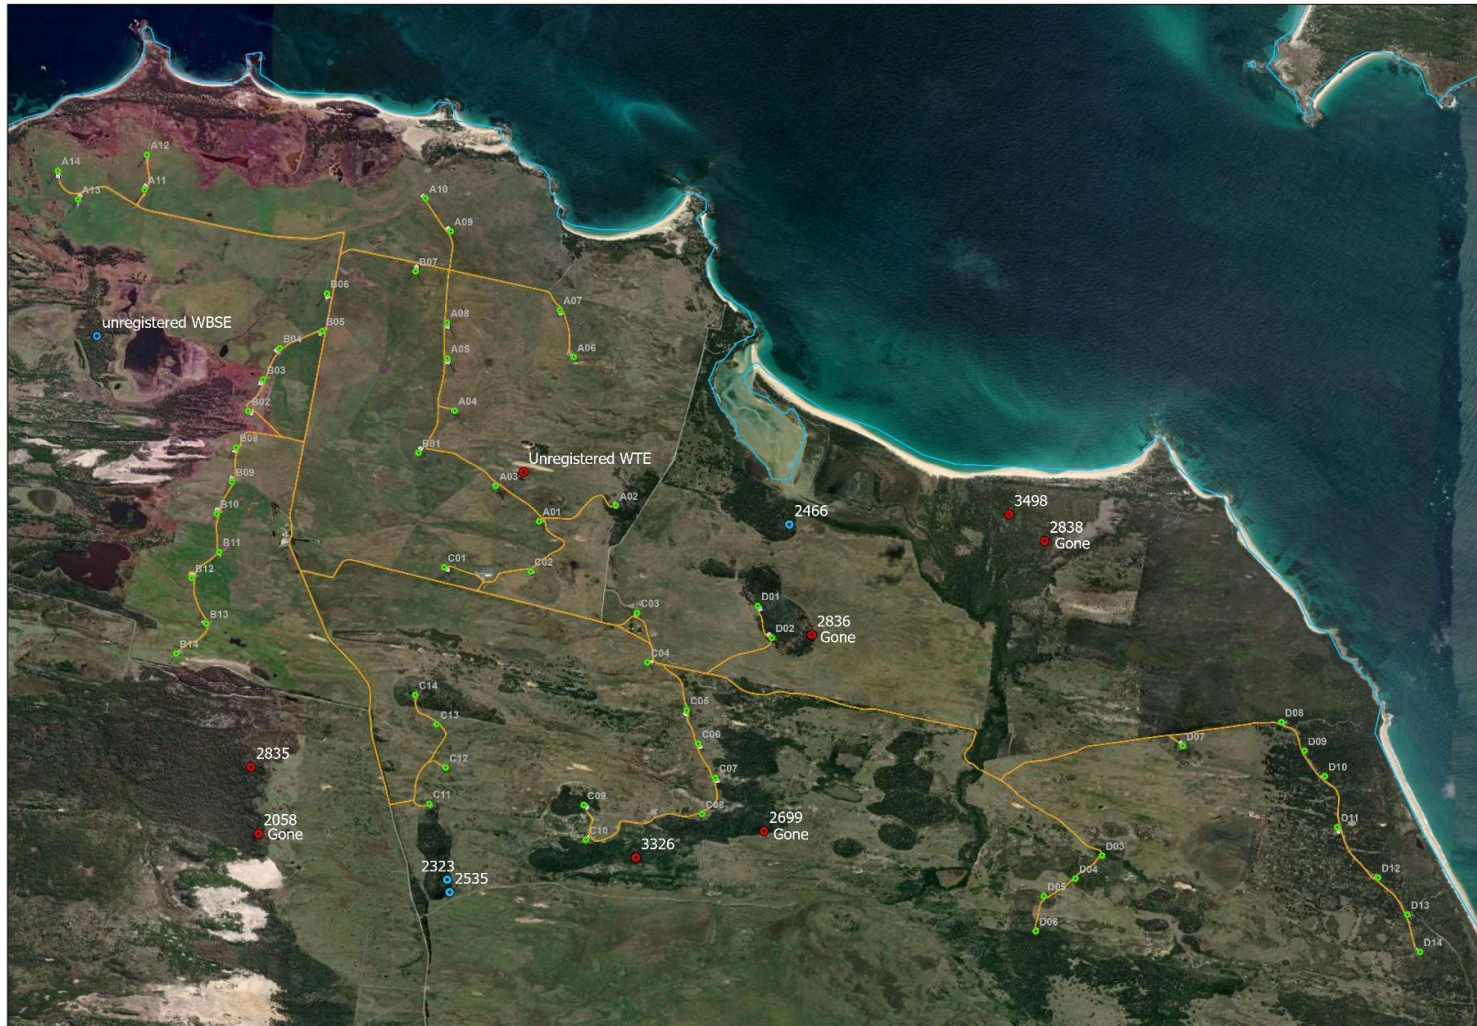
**Figure 5. Activity status and current species usage of wedge-tailed eagle (WTE, red dot) and white-bellied sea eagle (WBSE, blue dot) nests at MRWF (numbers correspond with Nest ID in the Natural Values Atlas).**

| Nest ID | Comment | Status |
|---|---|---|
| 2323 | This is an active WBSE nest site. Ecologists plan to survey the nest outside of the breeding season to verify its exact location as they noted the location shown in Figure 5 does not appear to be correct. | Active (WBSE) |
